URBAN ACCESSIBILITY IN THE HISTORIC CENTER OF SANTA MARIA FOR PEOPLE WITH PHYSICAL DISABILITIES AND/OR REDUCED MOBILITY

ABSTRACT

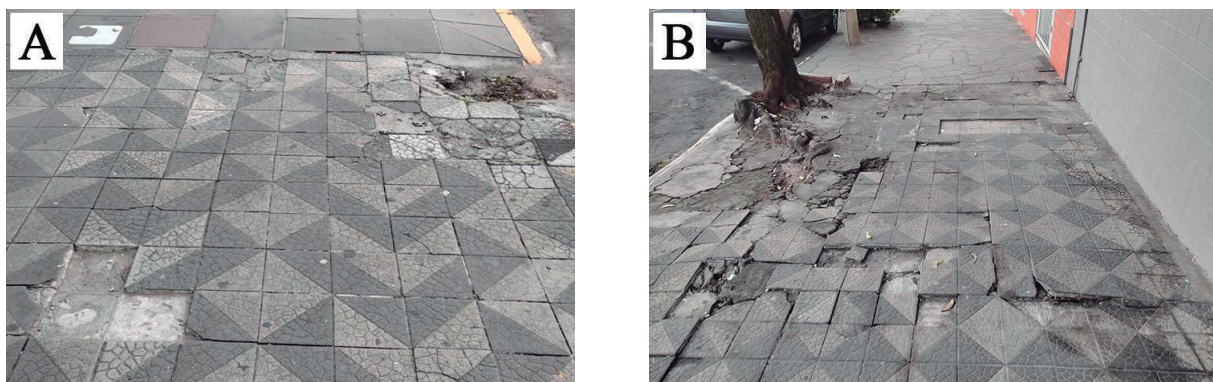
On Rio Branco Avenue, 59 obstacles caused some kind of danger and/or impediment to the movement of people, especially those with some kind of physical disability or reduced mobility. Of these, 15 obstacles were due to the lack of tiles on the sidewalks, which occupied part or all of the public sidewalk, characterizing a risk factor for locomotion, especially for wheelchair users.

Figure 1 - Lack of paving stones, hydraulic tiles, on the sidewalks in the area.

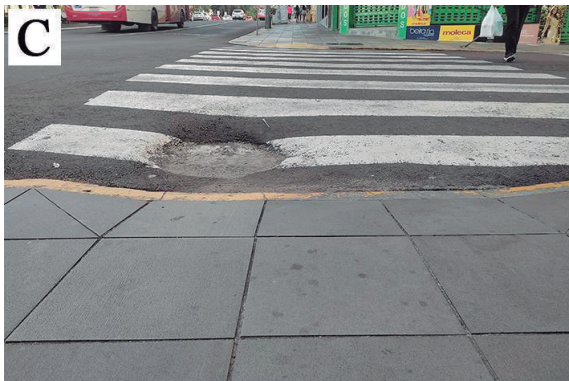
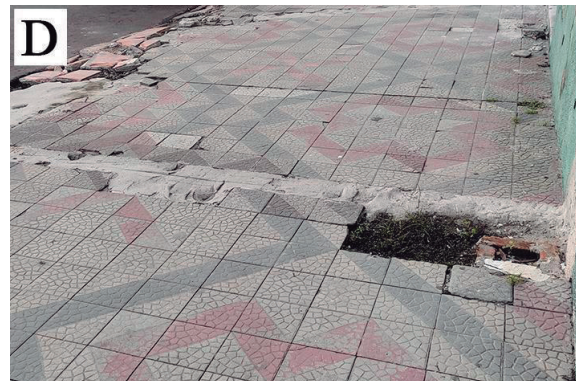
Six holes were also found along the sidewalks of Rio Branco Avenue, causing people with physical disabilities or reduced mobility to have to detour, which even causes discomfort for

Figure 2 - Holes in the safety lane in the image on the left and in the sidewalk in the image on the right.

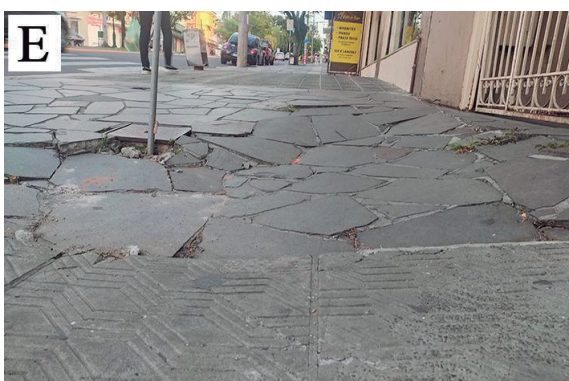
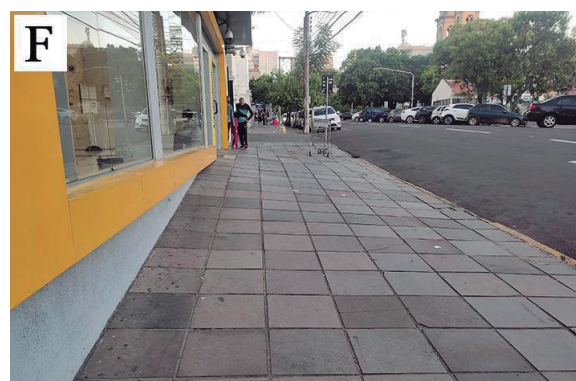
In Figure 3, you can see in item “e” that most of the sidewalk is uneven, which limits the walking space for people with physical disabilities and reduced mobility, especially when there is a large flow of pedestrians. In item “f”, the sidewalk has a very steep slope, making it extremely dangerous for wheelchair users to walk, in line with what P1 said.

Figure 3 - Uneven sidewalks.

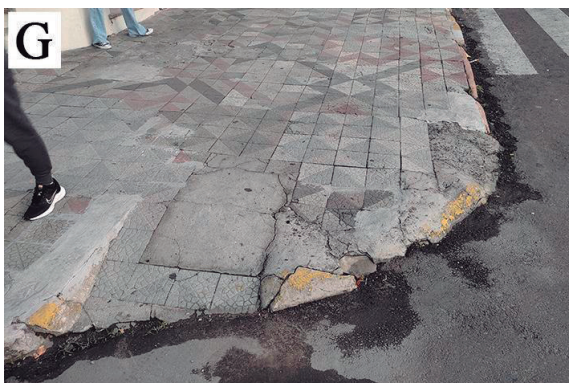
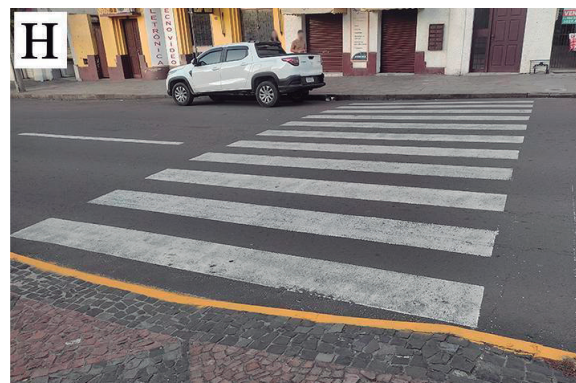
In Figure four, in item "g", the ramp is inadequate, without signage, without the proper slope and precarious. In item "h", there is no access ramp at the end/beginning of the crosswalk, making access to the other side of the street unfeasible.

Figure 4 - Access ramps not in line with technical standard guidelines.

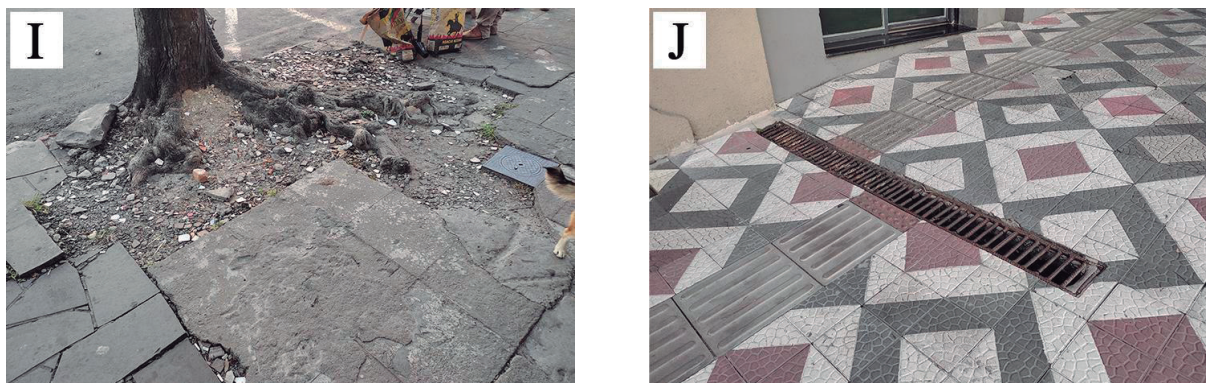
As a result of the vegetation, four areas were damaged due to tree roots and nine obstacles on the sidewalks, including posts, signs, garbage cans, rainwater collectors, and bus stops, making it even narrower for pedestrians to walk freely. In Figure five, item "i" shows that a large part of the sidewalk has been damaged by the roots of a tree, making it even more difficult for pedestrians to walk, especially people with reduced mobility and wheelchair users. Item "j" also shows the presence of a rainwater collector on a large part of the sidewalk, which hinders the movement of wheelchair users in particular.

Figure 5 - Damage from vegetation and obstacles on sidewalks.

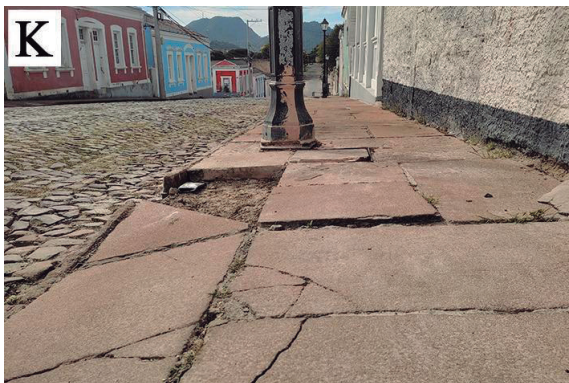
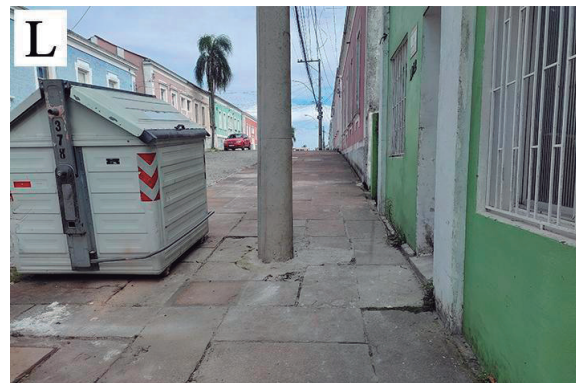
In Figure six, item “k” shows the lack of flooring and the uneven surface compared to the others, creating a risk of falls for pedestrians, especially people with reduced mobility. In item “l”, the garbage container on a large part of the sidewalk stands out, followed by a lamppost, making it narrower, and making it difficult for wheelchair users in particular to pass.

Figure 6 - Obstacles on the sidewalks of Vila Belga.

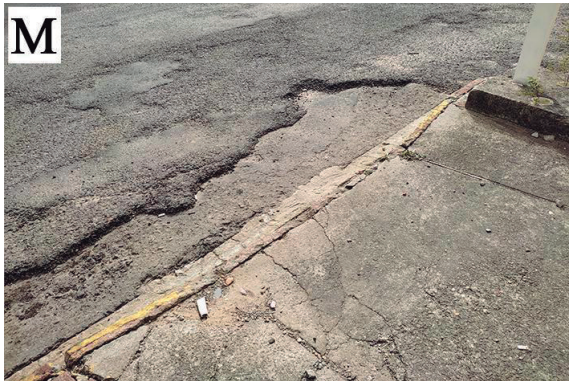
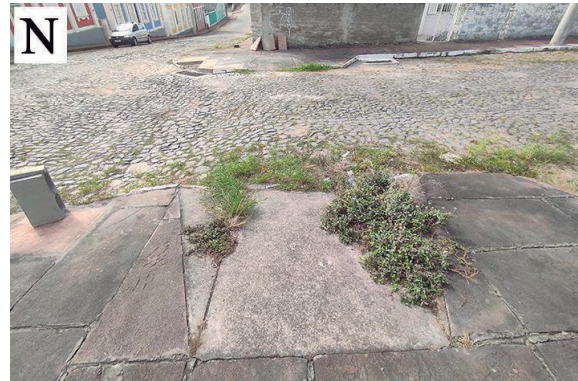
Concerning access ramps, only three irregularities were pointed out, since one was inefficient for use and did not meet the standards. Figure seven, under item “m”, shows an access ramp that is unsuitable for use and does not meet the standards:

This makes it even more difficult for people to walk, especially wheelchair users. As for item “n”, the ramps are only in poor condition, with vegetation growing, which can make it difficult for pedestrians to cross. In this sense, according to Junior (2007), public spaces are only accessible by eliminating physical and natural obstacles.

Figure 7 - Lowering sidewalks

Sidewalk curbs must be built in the direction of the pedestrian crossing flow. The slope should preferably be less than 5%, up to 8.33% (1:12), in the longitudinal direction of the central ramp and on the side edges. It is recommended that the width of the recess be greater than or equal to 1.50 m, with a minimum of 1.20 m allowed. The curb may not reduce the free circulation lane of the sidewalk by at least 1.20 m. (ABNT NBR:9050, 2020).

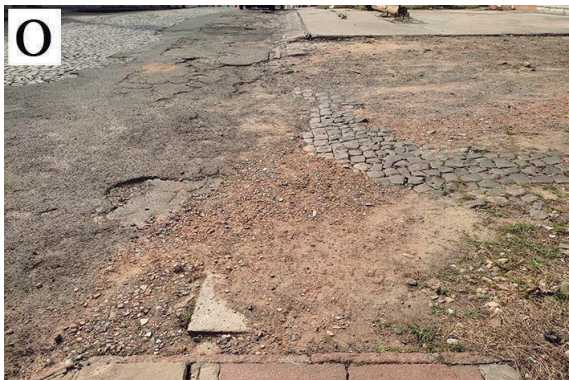
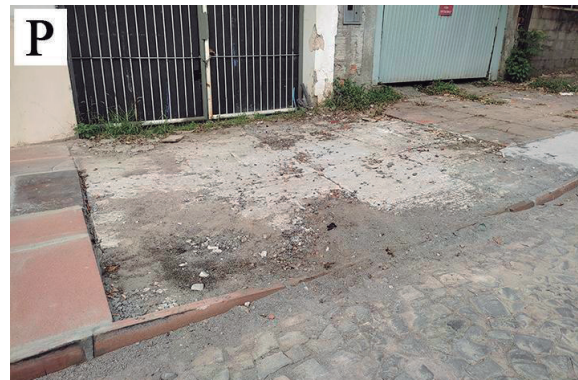
In items "o" and "p", attention is drawn to the familiarities of the absence of public sidewalks, which hinder the occupational performance of people with physical disabilities or reduced mobility.

Figure 8 - Lack of public sidewalks on some areas.

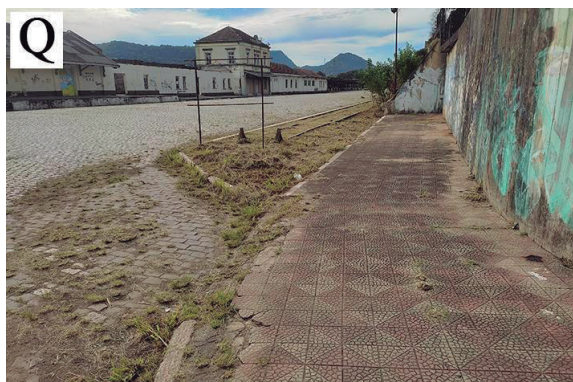
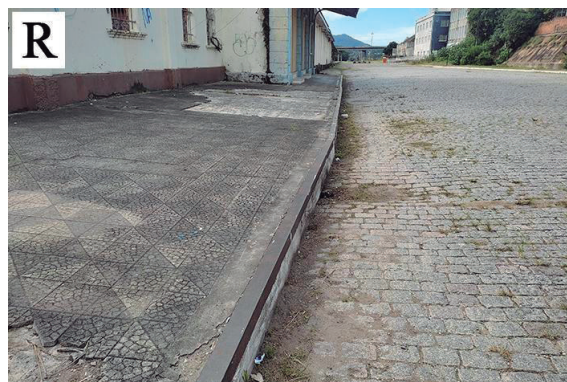
The site is inaccessible, lacking accessibility, ramps and public sidewalks, full of obstacles, potholes, and loose stones, among others. In this context, the lack of accessibility ends up keeping people with physical disabilities or physical mobility away from their leisure time, which is everyone’s right. The American Occupational Therapy Association (AOTA) (2015, p. 44) defines leisure as a “non-mandatory activity that is intrinsically motivated and performed during free time, that is, time not committed to mandatory occupations such as work, self-care, and sleep”. In figures nine and ten, items “q”, “r”, “s” and “t” show an alarming lack of accessibility in the Railway Station area.

Figure 9 - Lack of lowering of sidewalks in the square and in front of the Railway Station.

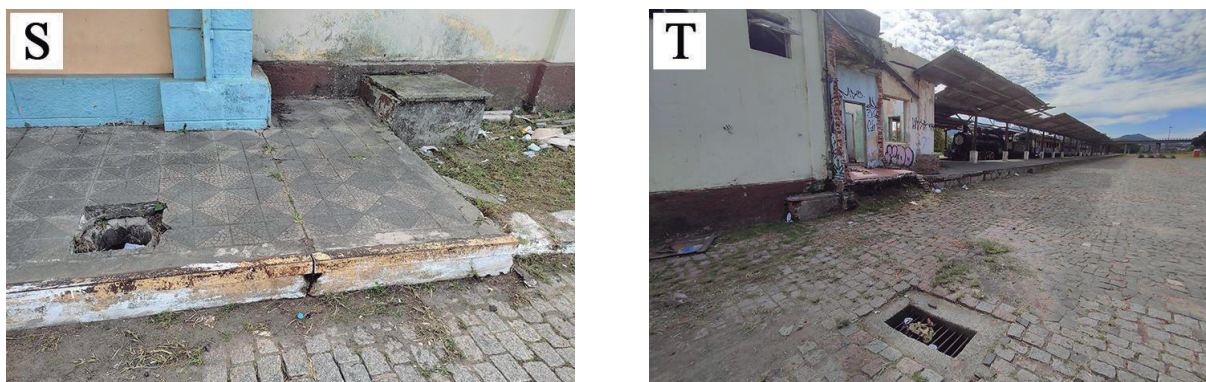
Figure 10 - Lack of accessibility in Railway Station.
